Technical Letter
No. 1110-2-286

Engineering and Design
USE OF GEOTEXTILES* UNDER RIPRAP

1. Purpose. This ETL provides information on experiences with geotextiles under riprap on the Tennessee-Tombigbee Waterway.
2. Applicability. This ETL applies to all HQUSACE/OCE elements and field operating activities having civil works responsibilities.

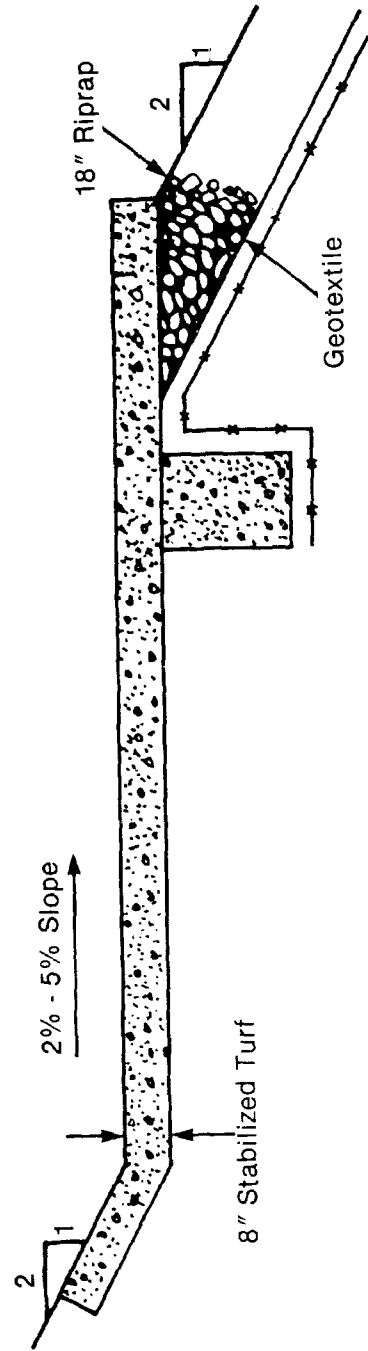
Figure 2. Stabilized Berm of Variable Slope Extending Over Riprap Combined with Entrenched Geotextile.

11. Surface Water. Failure to properly handle surface water resulted in many failures. The concept of sheet runoff was used in design but this proved to be inapplicable since the runoff tended to create channels in the highly erodible soils and undermine the geotextile. The geotextile was either clogged, of too low a permeability, or not in contact with the soil, causing the water to percolate down the slope under the geotextile instead of up through the textile and then down the slope on top of the textile. Any punctures or tears in the textile allowed the trapped water to exit and carry materials with it. Slumps or depressions in the riprap resulted, and in cases of heavy or prolonged rainfall, a complete washout and failure occurred. Burying the geotextile 2-3 feet deep in a trench at the top of slope after riprap placement helped greatly to control erosion, but it was not a complete solution (Figure 1). Modifying berm slopes and stabilizing berms with small rock were also tried and met with varied success (Figures 2 & 3). Collector systems for the runoff proved to be the best and most reliable overall solution but were expensive. Various combinations of ditches, paved channels, and pipes were used successfully. Figure 4 shows a typical collector system. See Inclosure 1 for Figures 1 thru 5.
